Watershed Based Plan Overview

Clarks Run Watershed
Boyle and Lincoln Counties
Kentucky

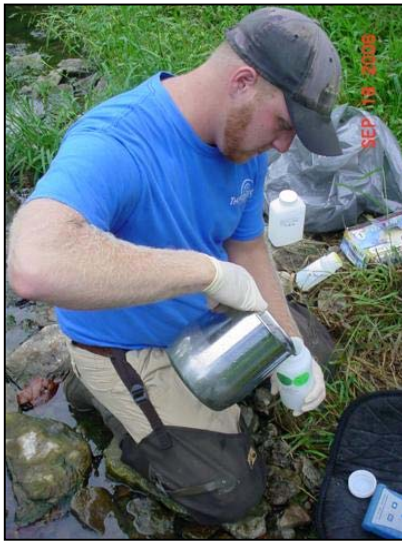
Sample Collection in Clarks Run

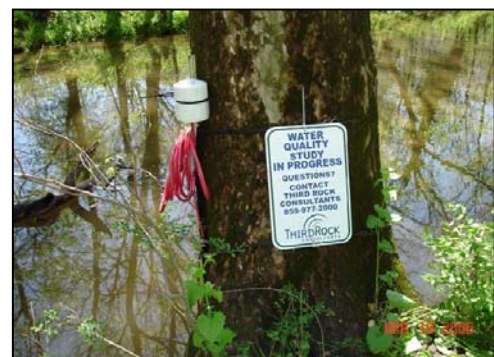
Signage for Flow Measurement Equipment

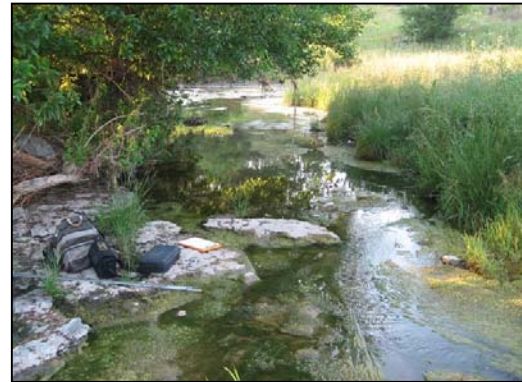
Algal Blooms and Absent Riparian Zone on Sampled Stream

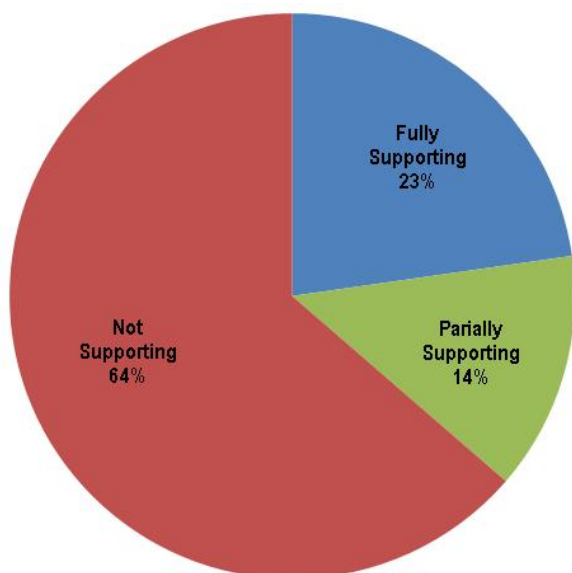
Figure 1 - Habitat Evaluation of Clarks Run

Of the twenty-two sites surveyed in Clarks Run, the majority of the sites were determined to have poor habitat, with over 75 percent either “not supporting” or only “partially supporting” habitat use. These designations are shown on Exhibit 2, on page 4. Although the reasons for the poor habitat designations differed from site to site, common trends were observed in the watershed.

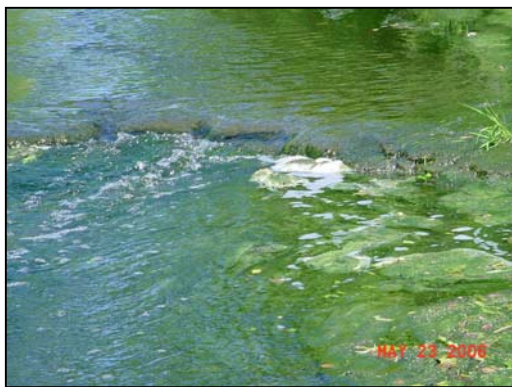
Algal blooms are rapid increases in a stream's algal population and are caused by an abundance of nitrogen, phosphorus, and sunlight. Algal blooms were observed throughout the watershed, but were especially dense nearby Goggin Lane, where they were clogging the entire stream.

Algal Bloom at Goggin Lane
